DEPARTMENT OF VETERANS AFFAIRS
MEDICAL CENTER
1055 Clermont Street
Denver, Colorado, 80220

Drawing Title
**SEVENTH FLOOR
HOUSEKEEPING AID CLOSETS LOC**

Project Title
**Correct Hot Water System
Deficiencies Phase 1**

Project Number
554-14-804

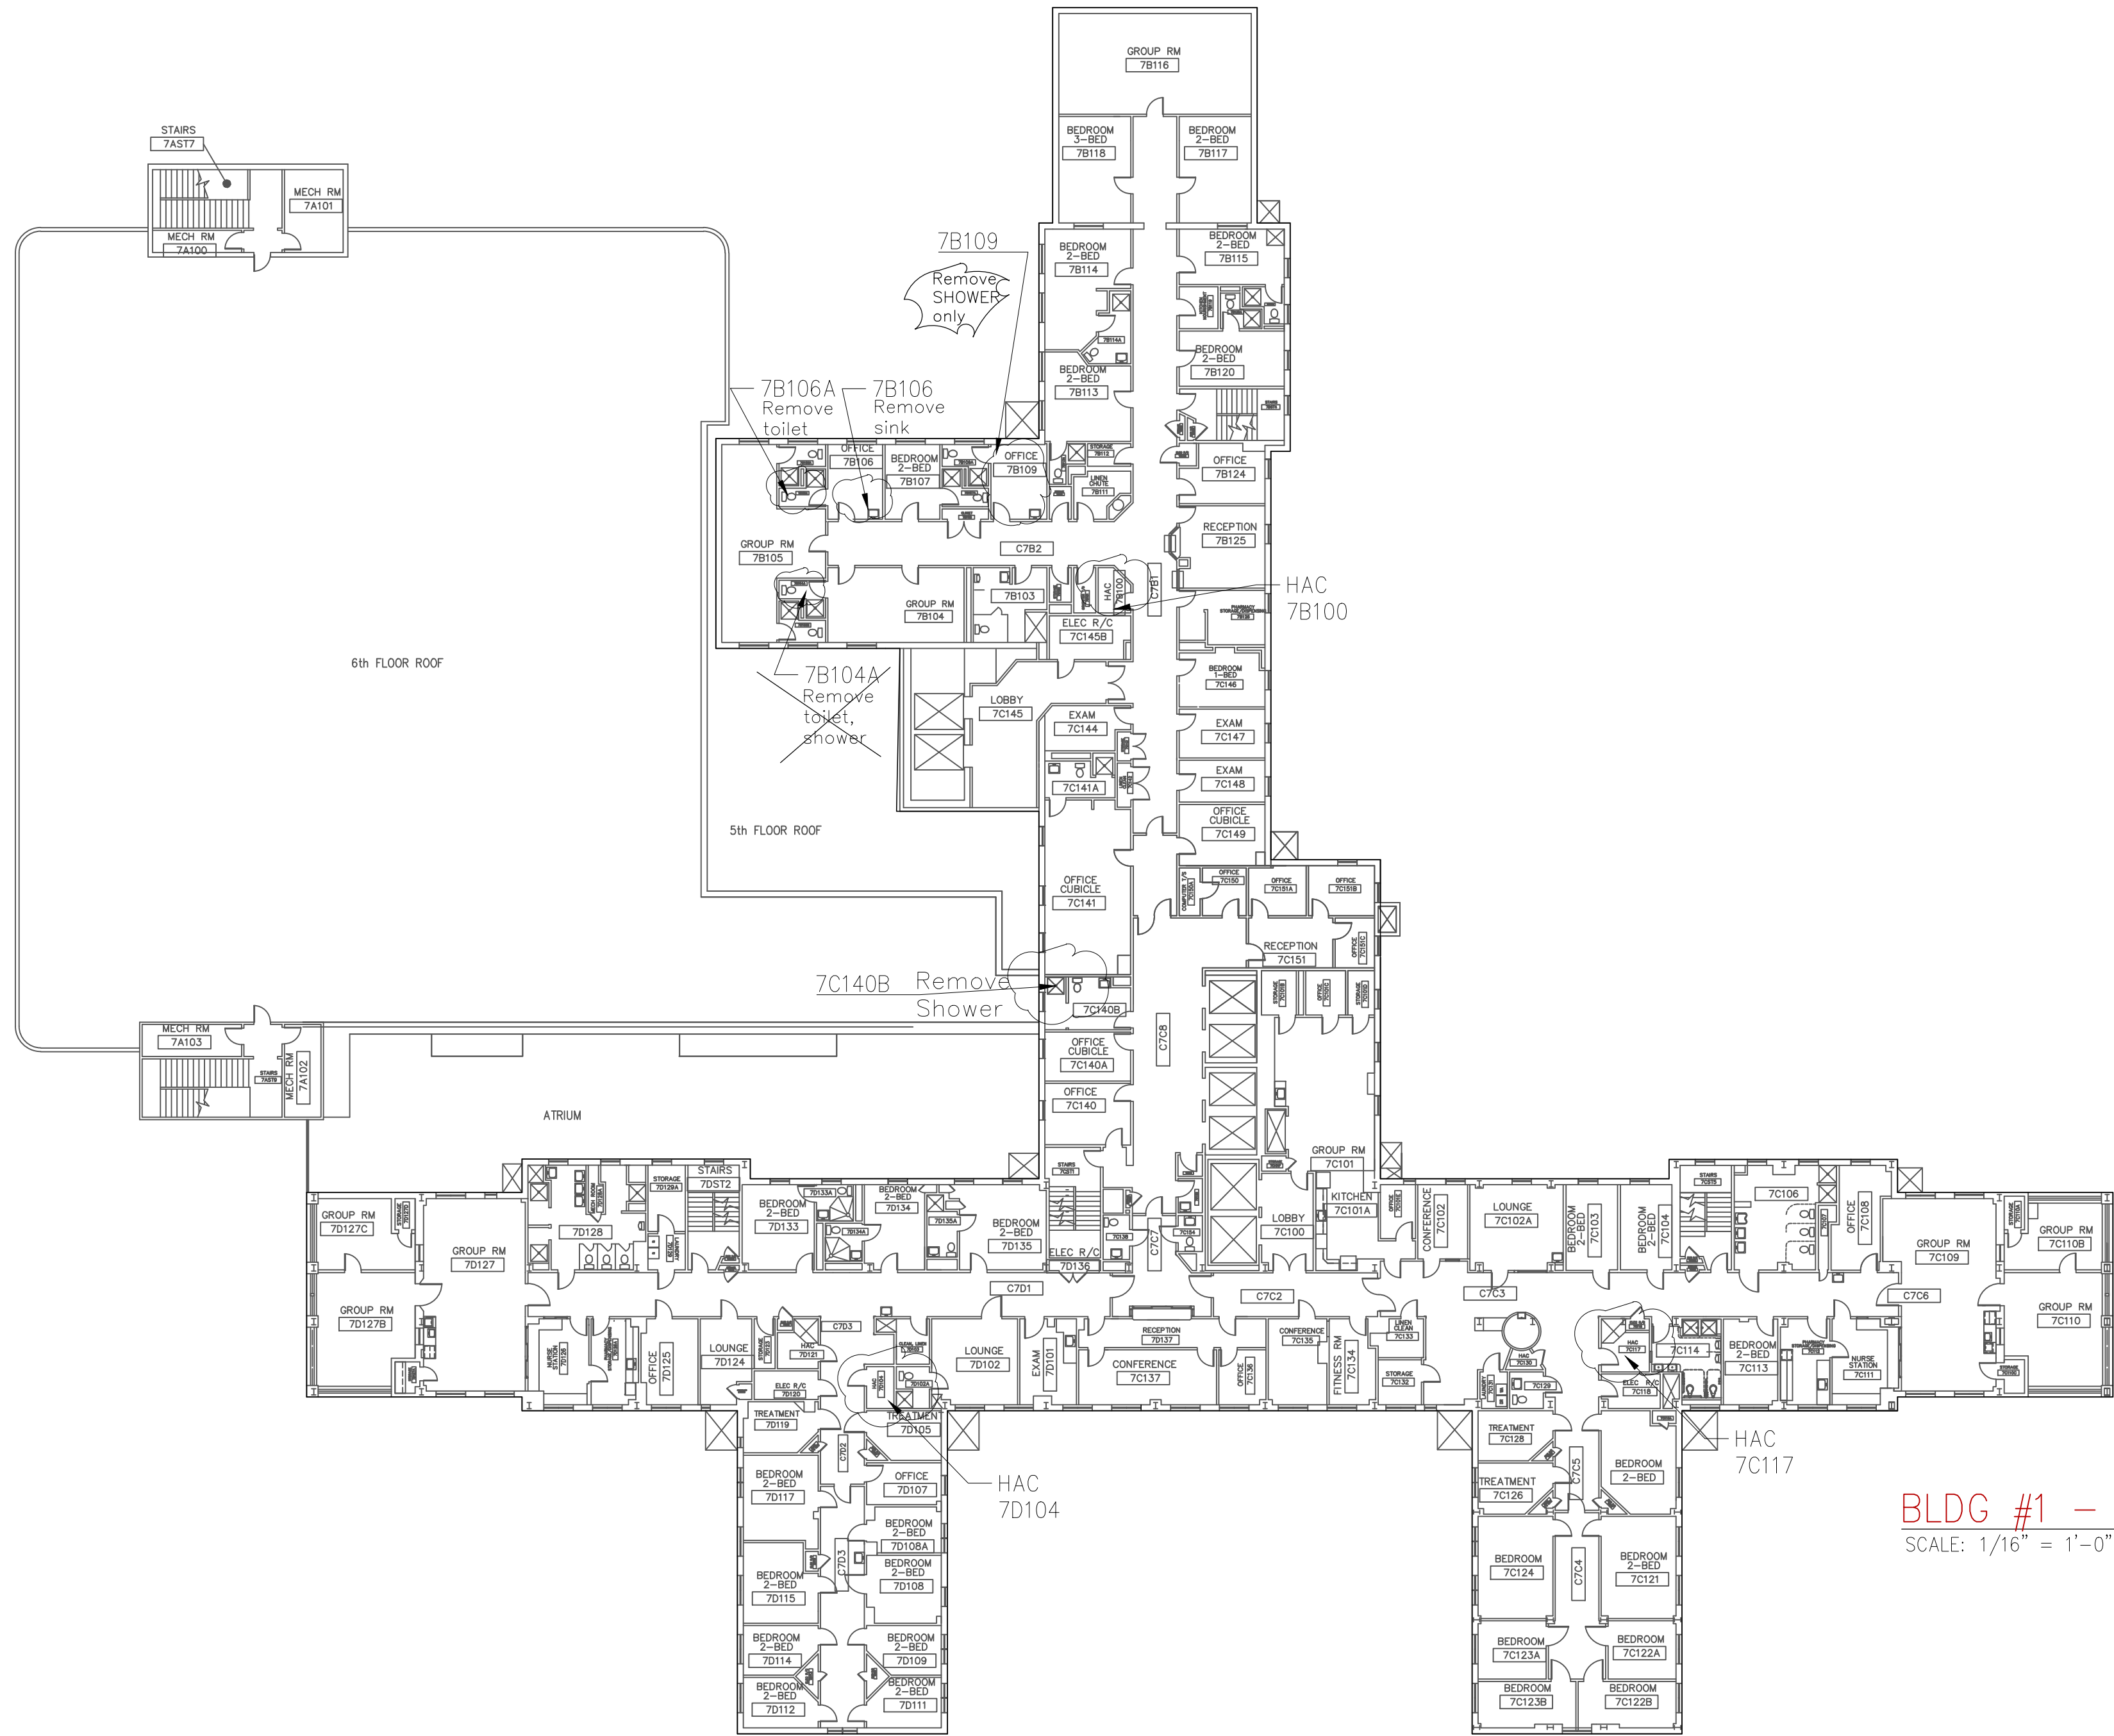
BLDG #1 - SEVENTH FLOOR
SCALE: 1/16" = 1'-0"

CONTRACTOR SHALL INSTALL NEW FAUCETS WITH CHECK VALVES IN ALL HOUSEKEEPING AID CLOSETS (HAC'S), TO ENSURE NO COLD WATER BACK FEED INTO THE CHEMICAL INJECTION SYSTEM. WORK MAY REQUIRE MINOR DEMOLITION AND REPAIR TO ACCESS VALVES IN WALLS/CEILINGS.

HAC'S Room #
7B199
7C117
7D104

REMOVE UNUSED/UNDERUSED SINKS, SHOWERS AND TOILETS IN LOCATIONS NOTED ON PLANS. PIPING WILL NEED TO BE CUT BACK AND CAPPED AT MAIN AND ALL "DEAD LEG" PIPING REMOVED.

Fixture (s) Removal Room #
7B104A
7B106
7B106A
7B109
7C140B

Remove Shower, not sink
